City of Prince George  
HISTORY SHEET

SHEET NUMBER	1368		Roll Number	
Legal:	LOT'S 11-12	BLOCK 160	D.L. 343	PLAN 1268
Address:	1613 5 <sup>th</sup> AVE.			
Sanitary Connection:	# 47	SIZE -	MATERIAL -	INV. 1887.33 CONNECTED YES
Water Connection	# 274	SIZE 1/2"	MATERIAL NOT GIVEN	METER - CONNECTED YES
Storm Connection:	# -	SIZE -	MATERIAL -	INV. - CONNECTED -
Cash Receipt No's:	WATER		SANITARY STORM	
CURB FROM PROPERTY LINE	19'		PAVEMENT WIDTH 42'	
B.C. HYDRO	UNDERGROUND CONNECTION EAST SIDE OF VAN. ST.			
B.C. TELEPHONE	UNDERGROUND CONNECTION IN LANE N' OF 6 <sup>th</sup> AVE. WEST SIDE OF VAN. ST.			
INLAND GAS	IN LANE & 2" MAIN

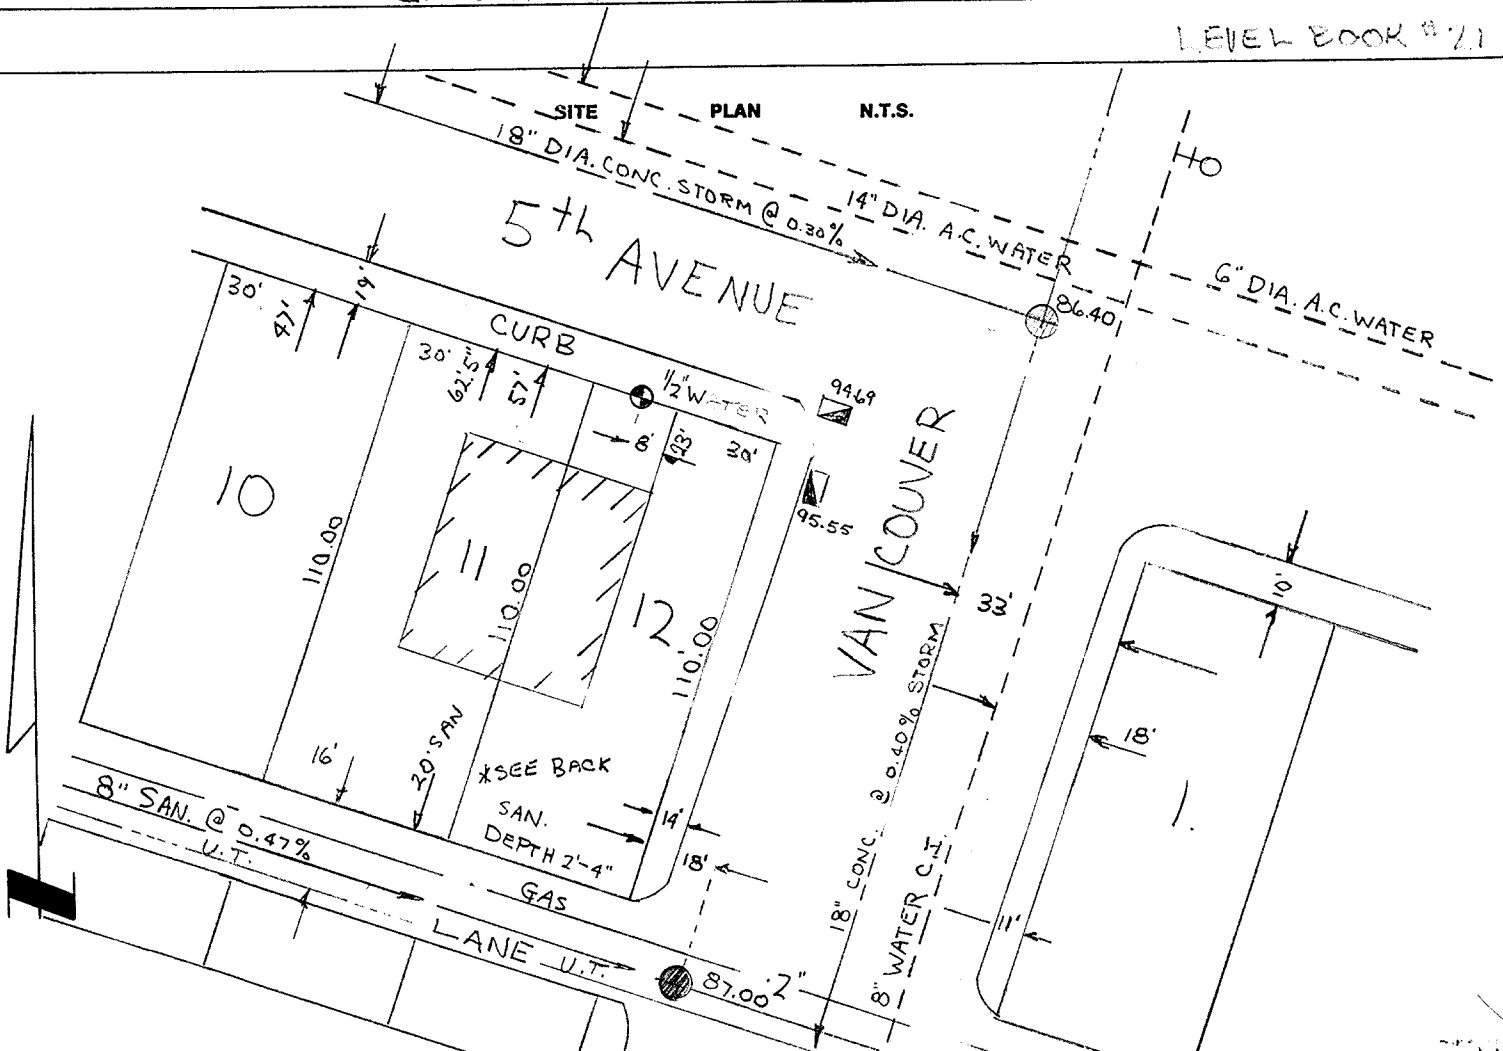
**Sanitary History:** SEWER HAD ALREADY BEEN LAID FROM HOUSE TO PROPERTY LINE BUT CONTRACTOR WAS UNABLE TO GIVE THE INFORMATION THUS A CONNECTION WAS LEFT AS SHOWN BELOW
