CITY OF
PRINCE GEORGE

Civic Address: 8298 CANTLE DRIVE

Legal Description: Lot: 2 District Lot: 625 Plan: 14430

Lot Services Sketch

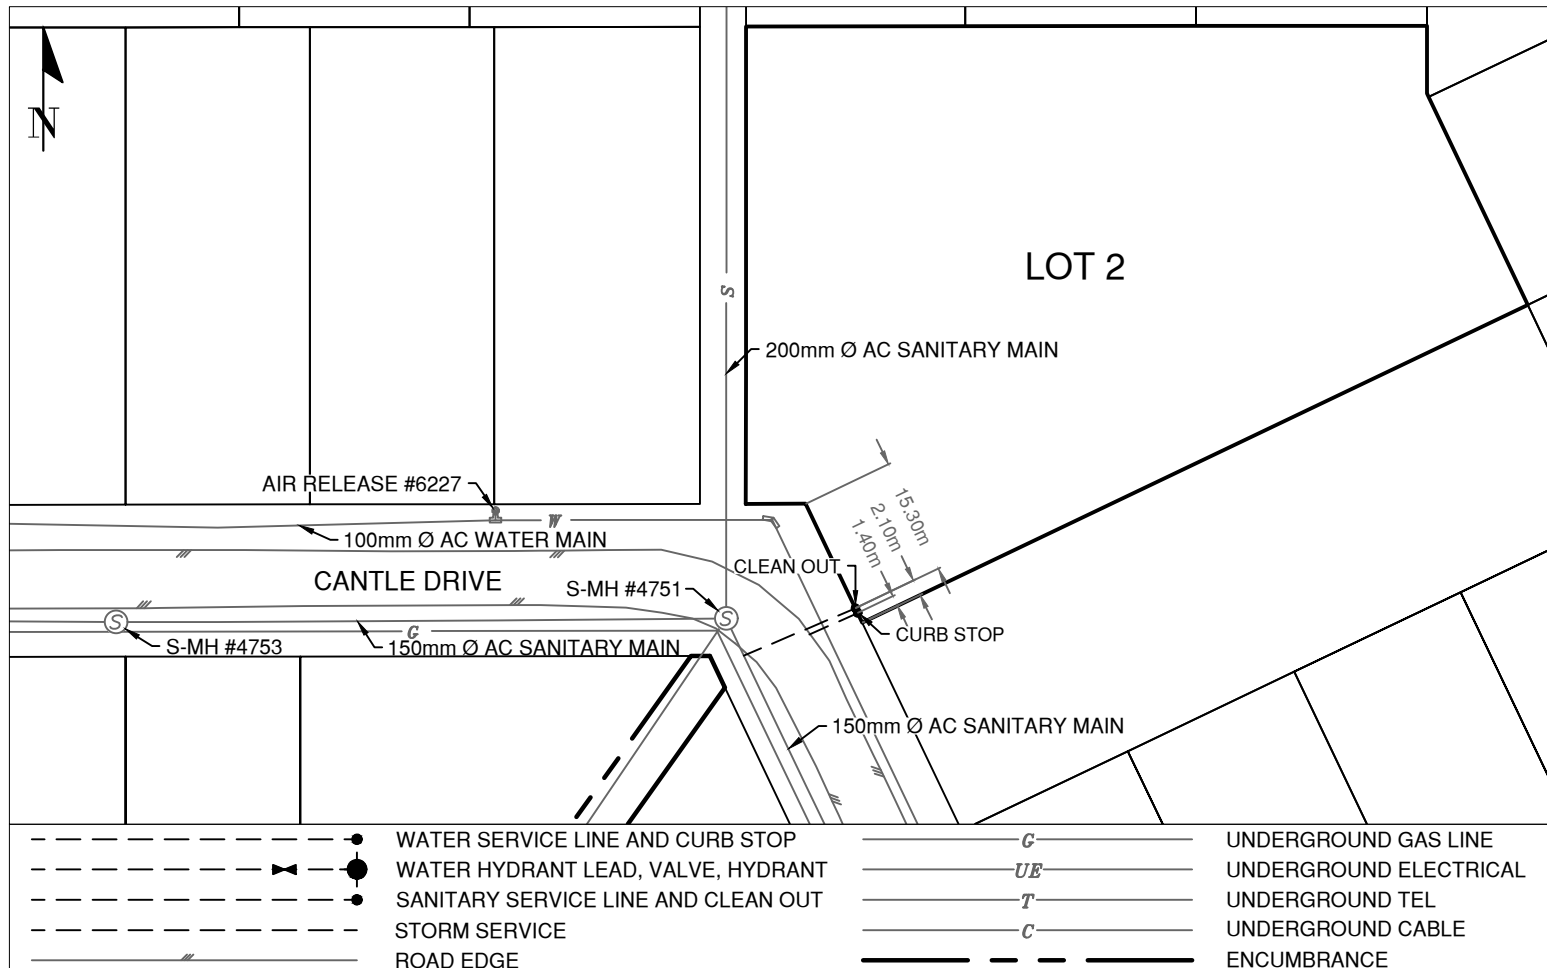
| Sanitary Service Connection Location Notes | Storm Service Connection Location Notes |
|--|---|
| Distance from downstream SAN MH #4751: 5.43m | Distance from downstream STM MH #: N/A |
| Distance to upstream SAN MH #4755: 96.46m | Distance to upstream STM MH #: N/A |

| Curb Stop is ~1.4m from the Southern property line of Lot 2. Clean Out is ~2.1m from the Southern property line of Lot 2. | | | |
